# **Producing Durable Continuously Reinforced Concrete Pavement using Glass-ceramic Coated Reinforcing Steel**

<b>Principal Investigator:</b>	<b>Sean W. Morefield</b>	<b>CERL</b>
<b>Co-Investigators:</b>	<b>Brett A. Williams</b>	<b>GSL</b>
	<b>Charles A. Weiss, Jr.</b>	<b>GSL</b>
	<b>Philip G. Malone</b>	<b>GSL</b>
	<b>Mike Koenigstein</b>	<b>PPEC</b>

# Presentation

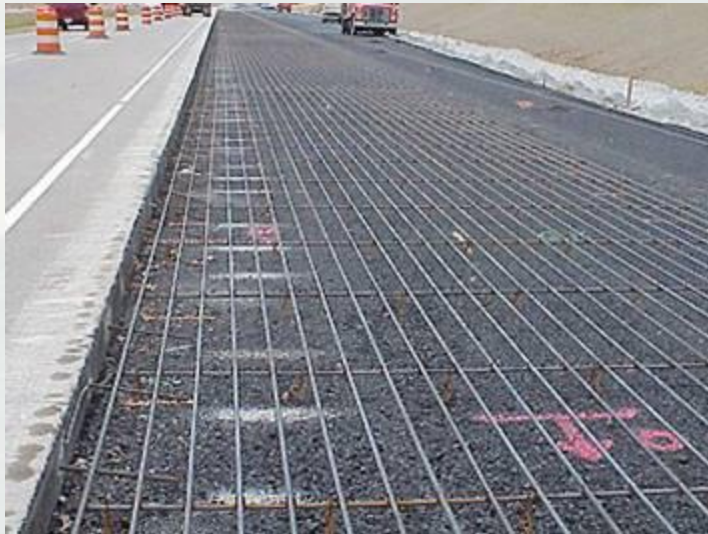
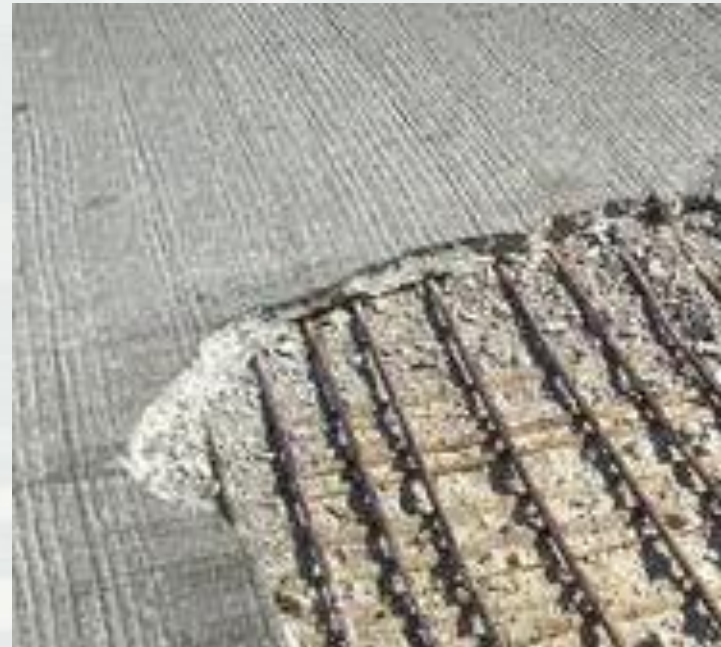
# **Corroding Steel Reinforcement is a Major Problem in Continuously Reinforced Concrete Pavement**

**The 600% volume change in the iron to iron oxide formation put the concrete in tension and it cracks and spalls**

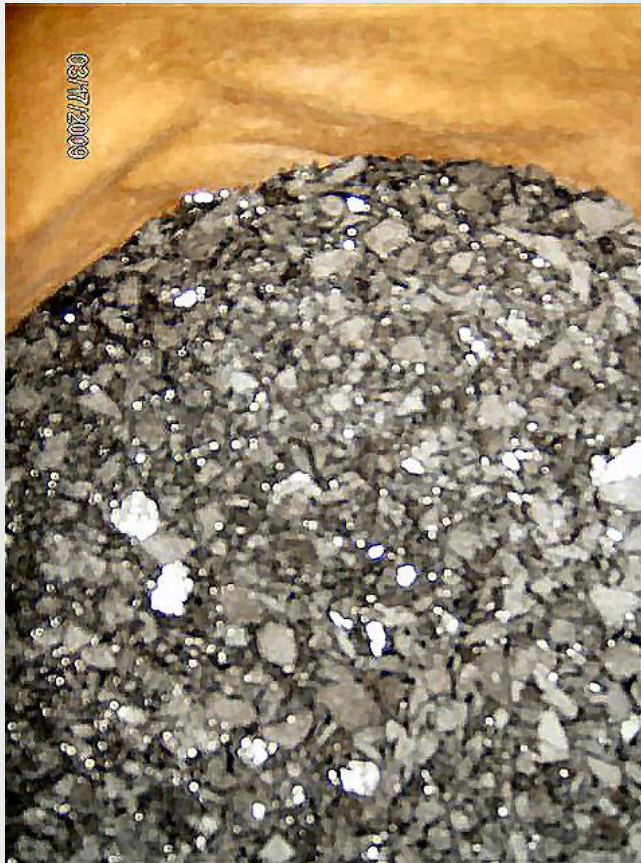
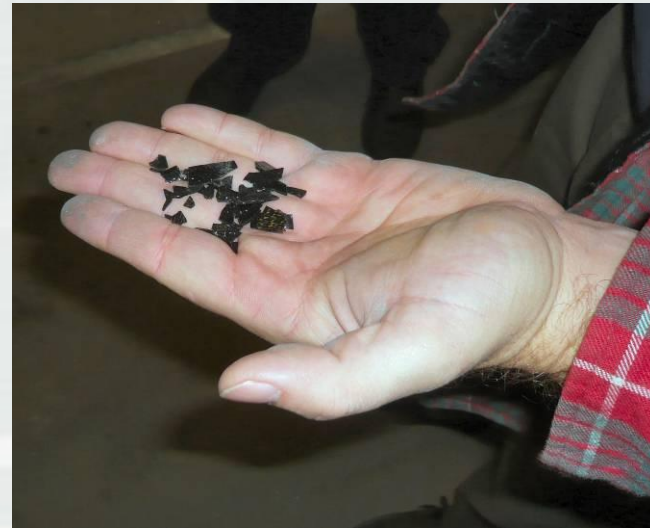
# Vitreous Enamel is Glass Fused to a Metal Substrate

**Cobalt and nickel-rich glasses will fuse tightly to steel forming an iron-rich interface.**

**Composition of the glass can be altered to change chemical resistance, bonding properties, coefficient of expansion**

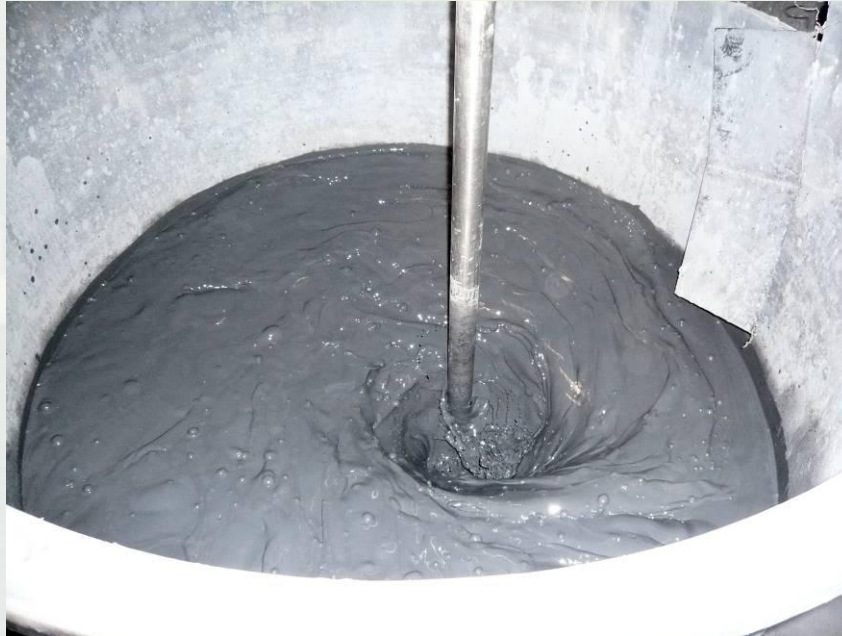
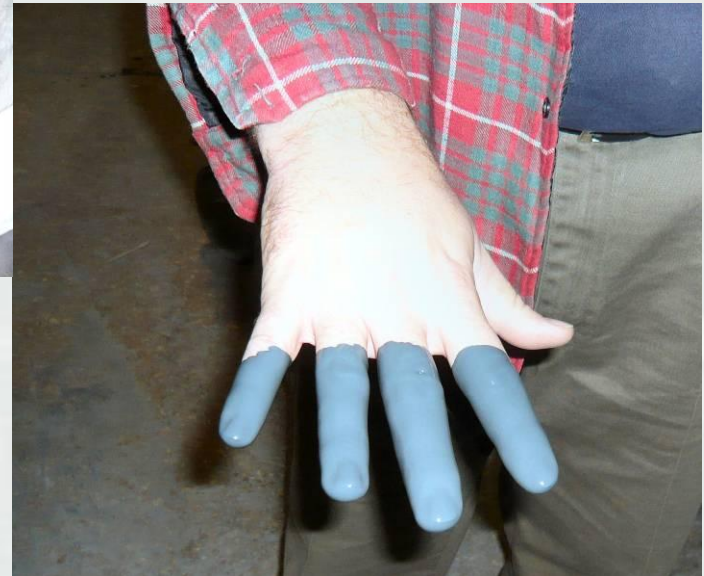
# Specialized Frits Used to Developed Needed Properties

**Steel-to-concrete bonding frit contains zirconium to make it alkali-resistant and a reactive Ca-silicate ceramic to make it bond.**

**The slip must flow, stick and the final glass must have proper thermal expansion properties to form a durable, strong, continuous coating.**

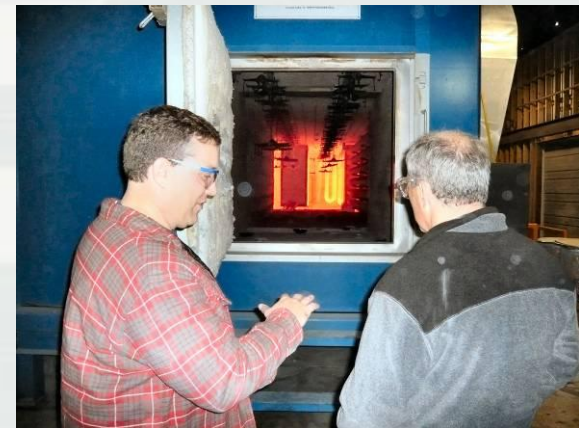
# Firing of a Vitreous Enamel is a Versatile Process

**Firing is typically done in minutes at the 750 C to 850° C range.**

**Fusing the glass can also be done by torch, plasma or induction heating.**

**Multiple coating and multiple firing can be used to build coating thicknesses as needed. Commercial enameling is a continuous process.**

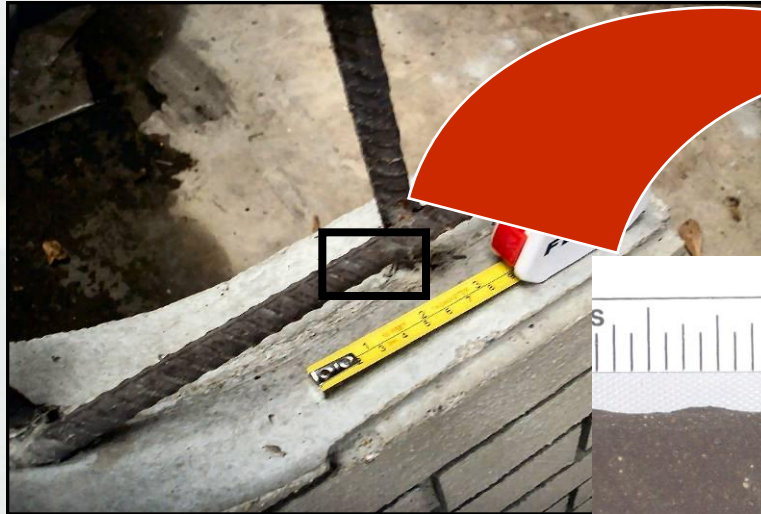
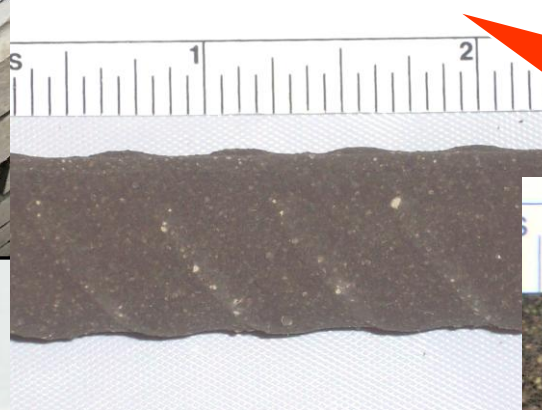
# Vitreous-Ceramic Coating On Rebar

Mild steels used in reinforcement enamel well

Portland cement is manufactured by firing the clinker at 1400 C

Enamel application produces no changes

After firing cement grains are embedded in glass enamel

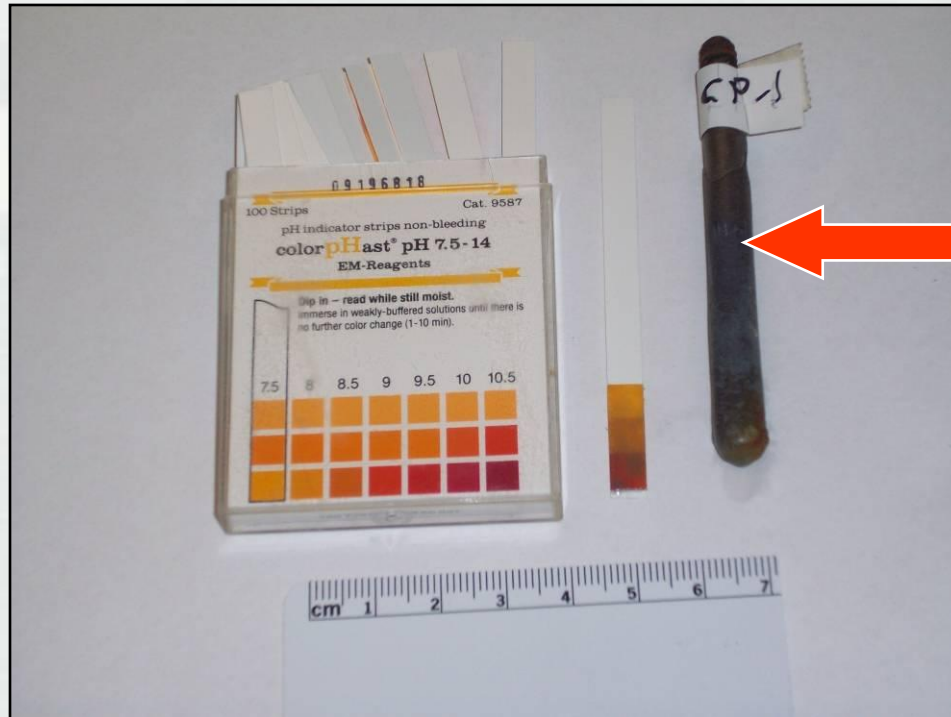
# Hydration of Embedded Cement

**Photomicrograph  
showing embedded  
cement grains**

**Moistened surface of rod with bonding enamel show  
the pH change indicating embedded cement is  
hydrating**

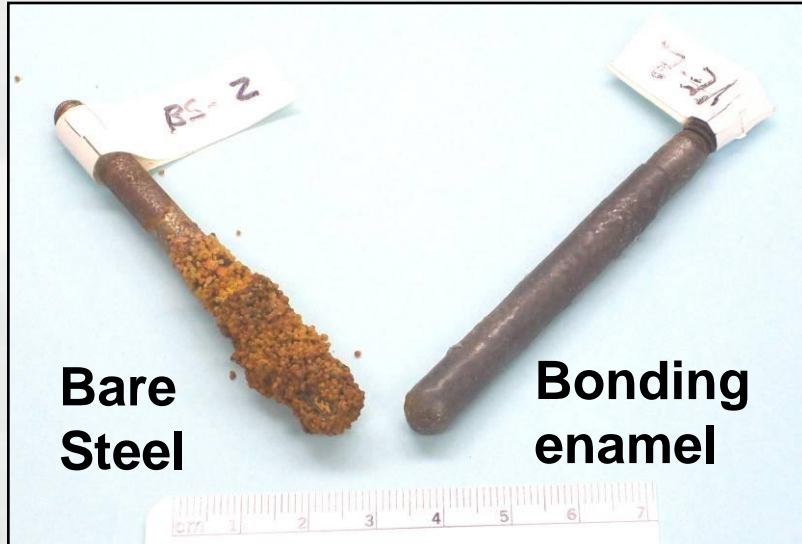
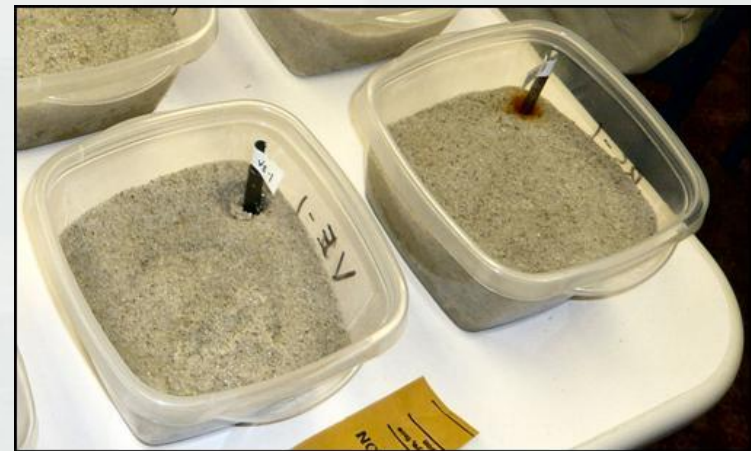
# Enameling Provides Excellent Corrosion Resistance

**Coated rods would only corrode if the enamel was intentionally removed.**

**Results of 40-day exposure of mild steel test rods with and without enamel in 3.5% NaCl solution at 20 °C**

**Quartz sand saturated with 3.5% NaCl solution was test bed**

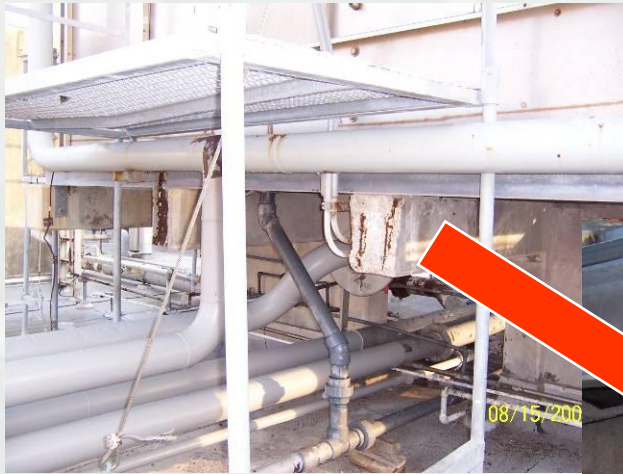
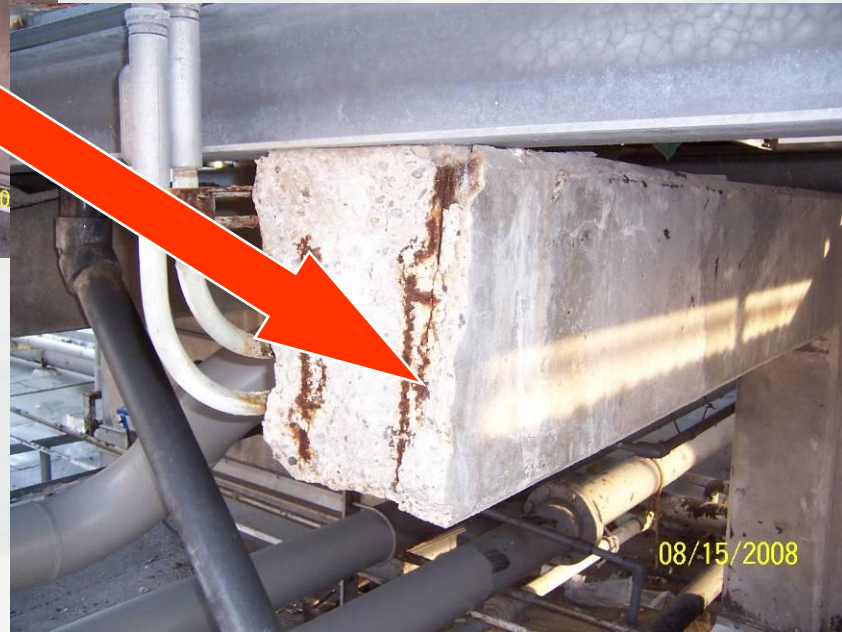
# Field Test at Corpus Christi Army Depot

**Proximity to Gulf of Mexico makes location prime test site**

**Corrosion of stirrup rebar in support beam caused end of the beam to fall off**

**Project replace beams 14,400 sq. ft. of CRCP**

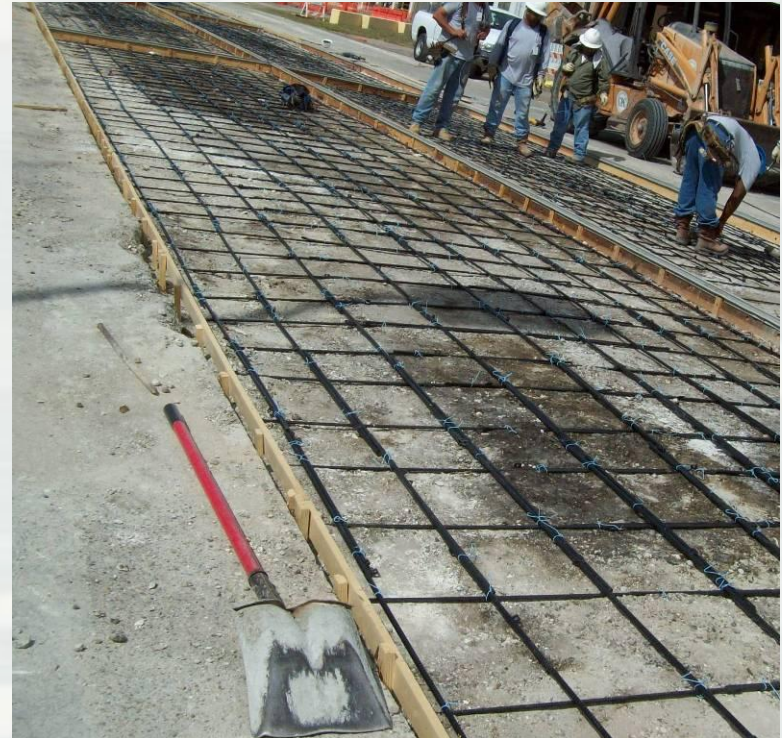
# Crecy Street Test Site at CCAD (2)

- Pavement is 6-in. thick
- Bars are positioned at mid-depth
- Bars were overlapped to form splices
- The overlaps vary from 12 in. to 20 in.

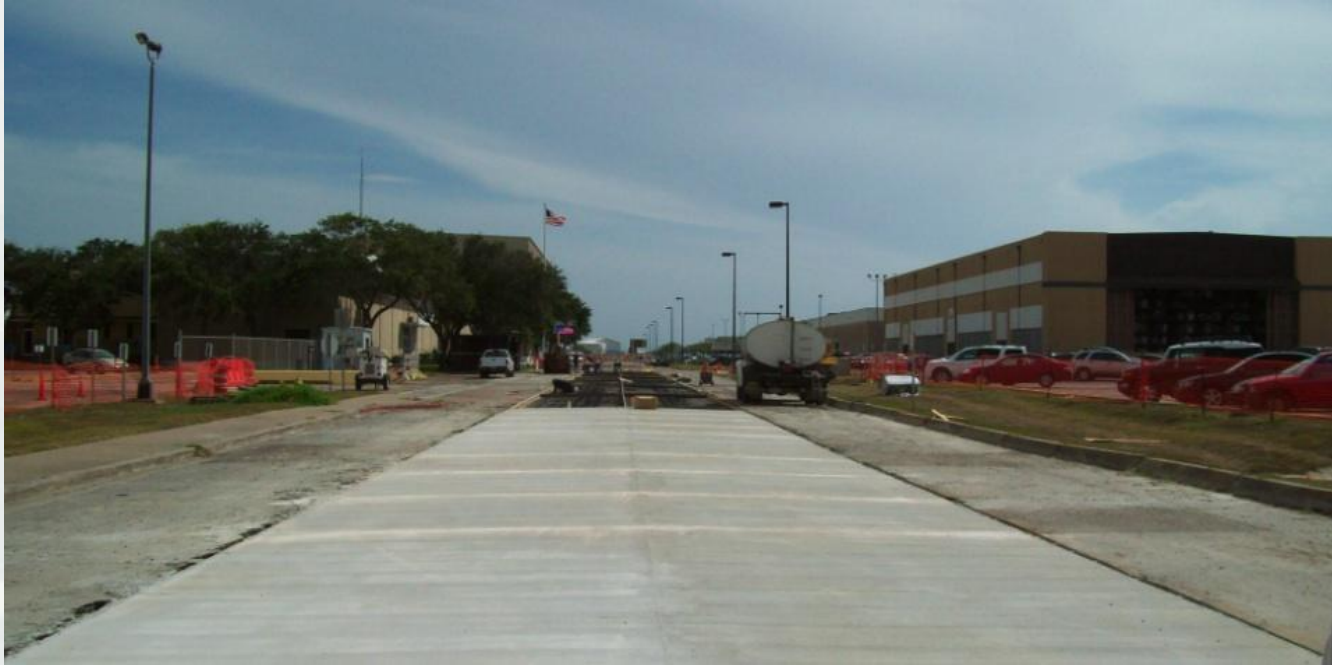
# Finished Section of CRCP at Crecy Street Test Site

The pavement design follows AASHTO GHDS-5-M for a 5000-car per day traffic load
